CASE STUDY

A basis water quality monitoring plan for rehabilitation and protection

M.D. Enriquez *, R.M. Tanhueco

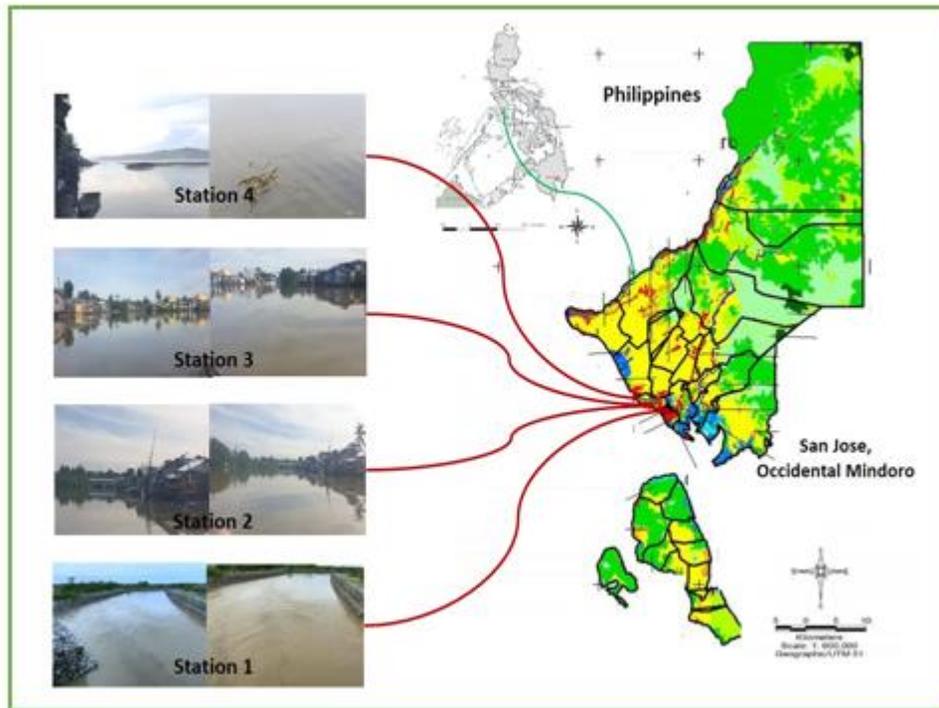
Fig. 1: Geographic location of the study sampling stations at San Jose, Occidental Mindoro, Philippines

Pandurucan River is located at San Jose, Occidental Mindoro covering San Roque and Labangan Poblacion on its midstream and downstream sections. The river is generally used for recreational purposes as swimming and bathing which are commonly observed and enjoyed. Four sampling stations were selected based on the drainage pattern and probable point sources and the center of commercial and residential areas. Table 1 shows the descriptions of the sampling stations.

Stations	Description
Station 1: Labangan Poblacion	The station is located at 12° 21' 55"N 121°04'36"E at Labangan, San Jose, Occidental Mindoro. It is located in mangrove areas with riverbanks riprapped with nearby salt farm. The station is characterized by clear water during the dry season and muddy water during the wet season while the river bed is covered with pebble stones. Under the Type A climatic conditions, average temperature in the site is 27.96°C with rainfall amount 113.23 mm. Most of the land cover is agricultural use and generally residential and commercial areas.
Station 2: San Roque	The station is located at 12° 21' 54"N 121°04'00"E of San Roque, San Jose, Occidental Mindoro. At the station is the Pandurucan Bridge with river water characterized by scattered garbage in the river banks and surrounding mangrove. The water is typically greenish to brownish and a foul smell can be observed. The river bed is covered with muddy clay. The station is also covered of Type A climate conditions with average temperature of 28.29°C and accumulated rainfall amount during the study period of 3,634.90 mm. Most of the land cover surrounding the station is categorized as highly dense residential, residential and commercial areas.

Station 3: Market area	The station can be found in 12° 21' 20"N 121°03'52" E with visible residential houses, garbage and waste on the riversides, snail shells in the river banks with greenish to brownish water. A foul smell can also be observed. The river bed is also covered with muddy clay. The station is generally surrounded by residential areas and commercial establishments. The rainfall pattern is the same as Station 2 with an average temperature of 28.32°C.
Station 4: Downstream-outlet	The station is situated at 12° 21' 01"N 121°03'41"E of Brgy 5, San Jose, Occidental Mindoro. The station point is characterized by residential houses with garbage (diapers and plastics); a mass of soil that separates the river and the sea. There are swimming children can be seen, and the river bed is covered with a sandy bottom. The water is bluish during sunny weather. The station is considered as the outlet of the river since it faces an opening to Mindoro Strait. Average temperature in the station is 28.42°C.

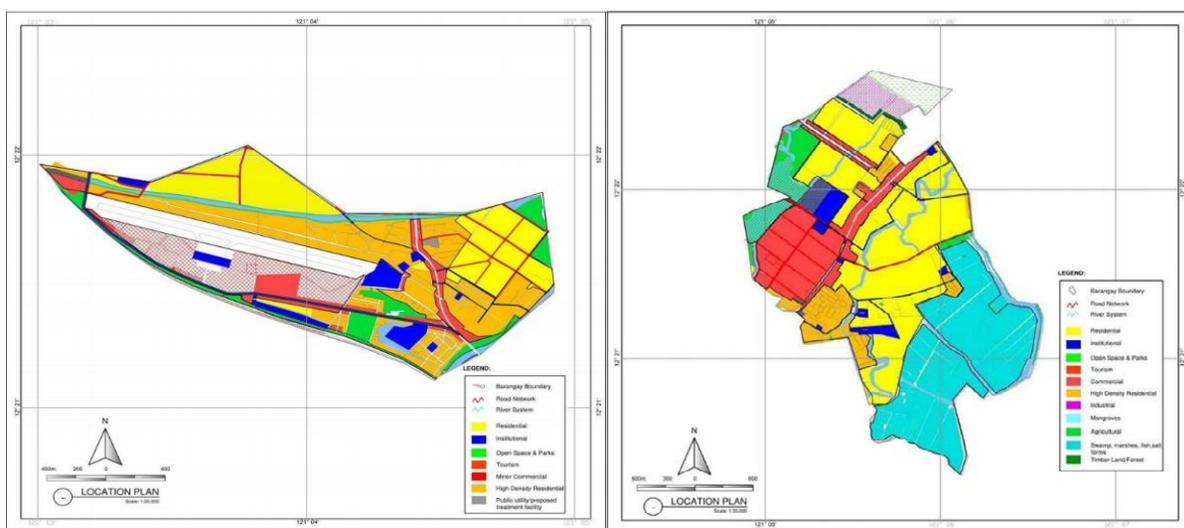
Fig. 2: General land use map of (a) San Roque (b) Labangan Poblacion (LGU San Jose, 2017)

In general, the land use pattern in San Roque is mostly covered with high-density residential: residential and minor commercial areas. Most of the commercial areas are found along the coast of Aroma Beach and San Jose Airport. The coastal barangay of San Roque is located just a kilometer away from the town of San Jose along the Pandurucan River separating it from the town (Fig. 2). The mode of transportation is mostly thru tricycles that can roam around the town via cemented roads. On the Eastern part of the area is the town proper of San Jose and Bubog: North (LGU San Jose, 2017).

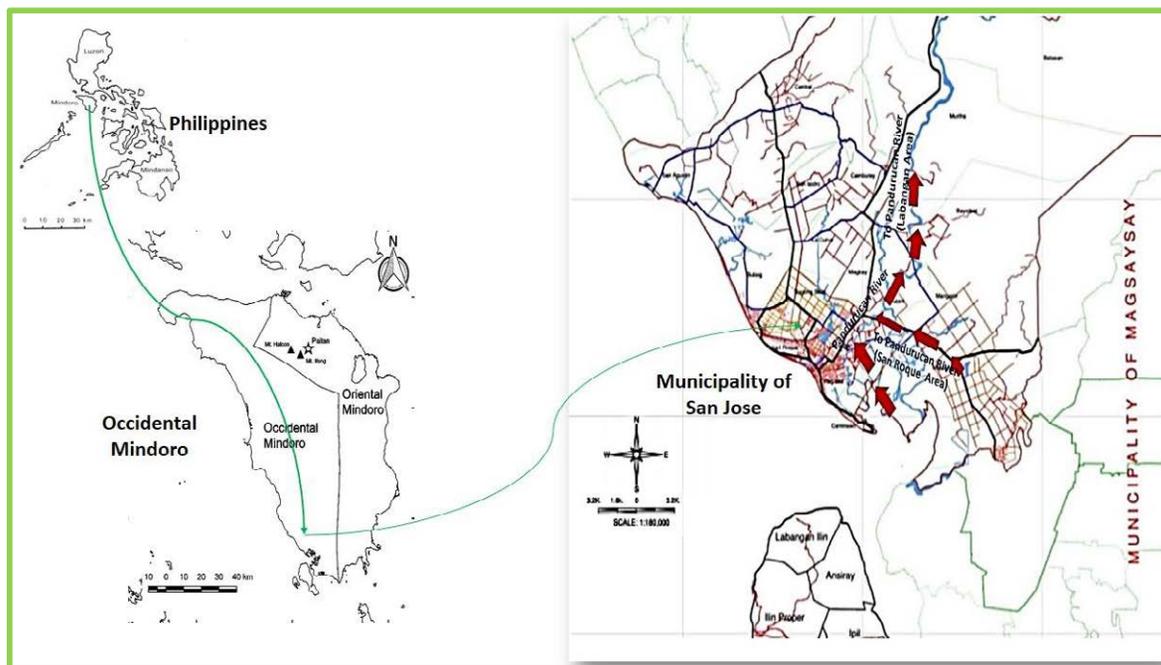
Fig. 3: Geographic location of the study area along with the existing drainage system in San Jose, Occidental Mindoro, Philippines

Drainage pattern can also affect the river system as it determines contributing factors and possible sources of contamination. In general, drainage in San Jose is composed of curb type and steel grated box type. However, there are still some areas in the municipality that do not have a reliable drainage system. All existing curbs and gutters in the municipality drain water to the Pandurucan River. While those that are in the area of San Roque drain water in the Bubog River. Fig. 3 shows the drainage system in the study area.

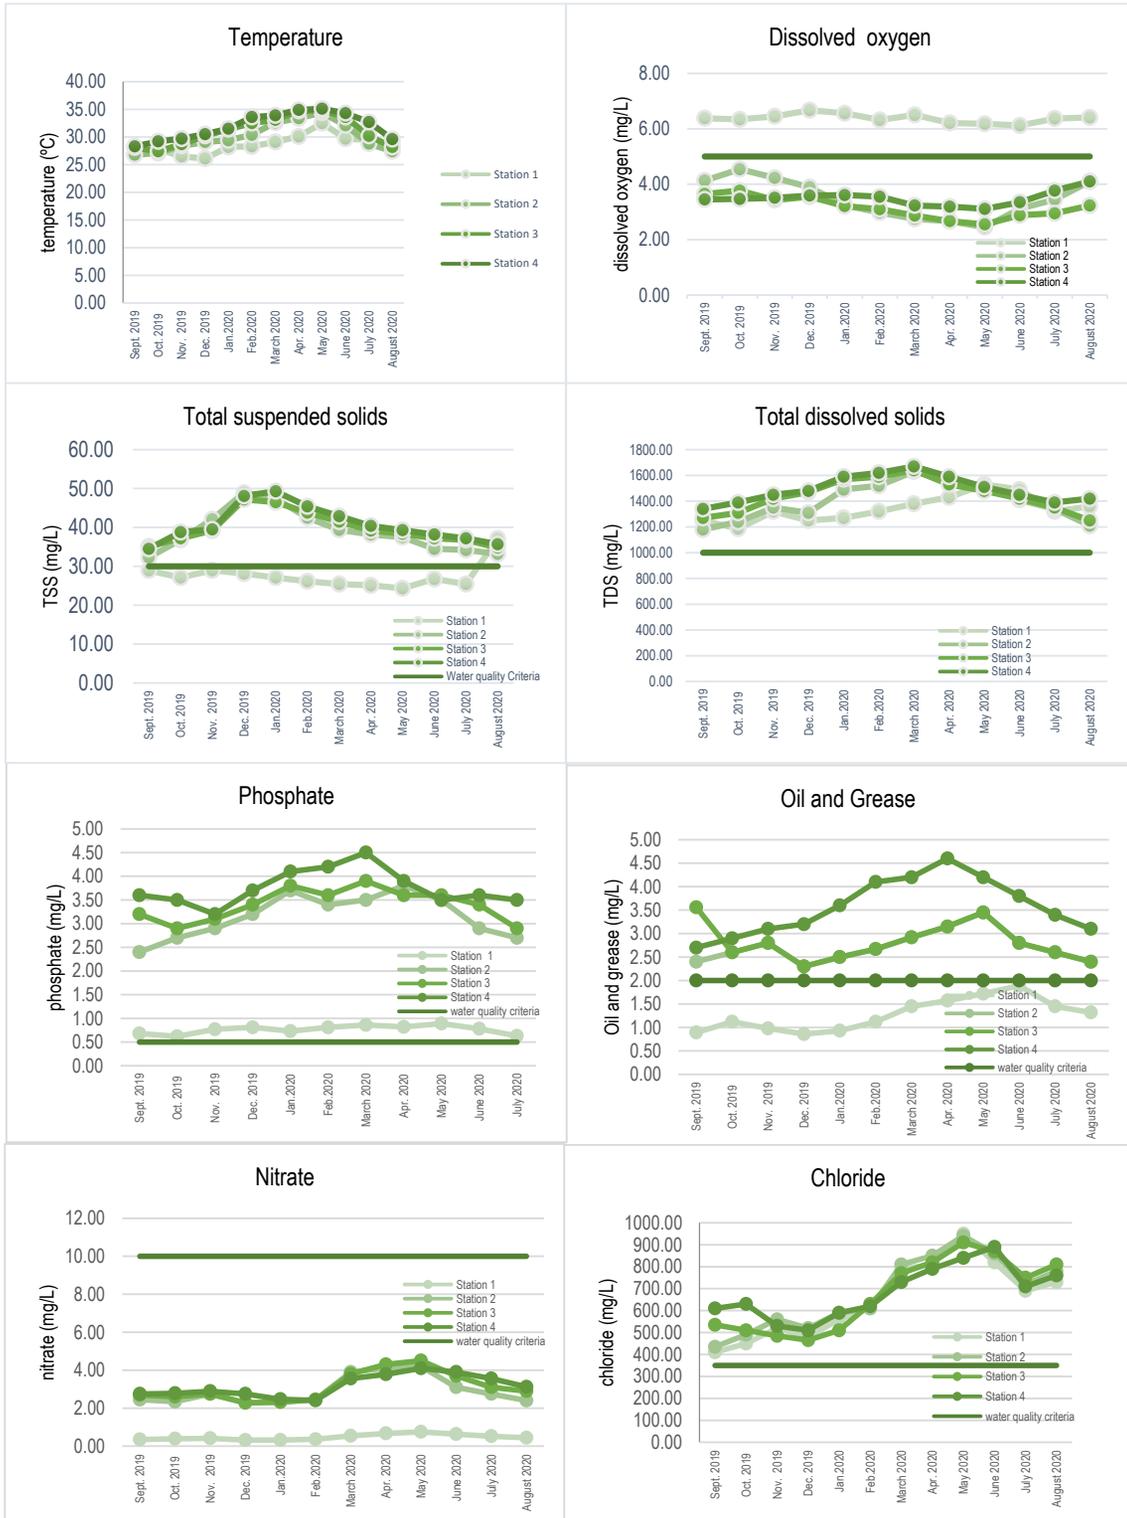
Fig. 4: Measured concentrations of physical –chemical water quality parameters in all stations

Following the procedures for in situ and laboratory analysis, the following results were observed. Water samples consider the wet season and dry season from September 2019 to August 2020 (Table 3). While, Fig. 4 shows the measured concentrations of each sampling station.

level below 5.0 mg/L compromises aquatic life and significantly indicates poor water quality (Liu *et al.*, 2009; Li and Bishop, 2004). Measured DO in stations 2, 3, and 4 showed higher values and beyond the allowable limit. Lower DO in the sampling station is manifested by limited aquatic life with only spire snail shells and other small crustaceans are present. While DOs measured in station 1 were higher than 5.0 mg/L indicating healthy water as fishes and other crustaceans are observed in the site. Suspended solids containing much organic matter may cause

with aerobic and anaerobic biological processes. Measured concentrations for oil and grease were higher during the dry months as it ranges between 1.08 to 3.5 mg/L with water samples from Station 1 conforms to the acceptable limit of 2 mg/L. Oil films are also observed in water surfaces of stations, 2, 3, and 4 indicating the presence of contaminants (Moslem et al., 2013) comprising the usability of the river system (US EPA, 1999). The allowable limit for nitrates concentration is 10 mg/L and an excessive amount may lead to algal bloom causing depletion of oxygen affecting the aquatic life (DENR-EMB, 2016). The measured concentrations of nitrate in the four sampling stations do not exceed the allowable limit but higher values were measured during March and May where agricultural activities are dominant in the surrounding environment as runoff from nitrogen fertilizers, domestic wastewater, human and animal waste are commonly observed (Wright et al., 2004). Chloride is a measure of sodium and potassium content of the water samples and must be less than 350 mg/L for freshwater (DENR-EMB, 2016). High chloride in the water body indicates saltwater intrusion. All water samples in all stations exceed the normal value for the freshwater significantly describing that the water is salty.

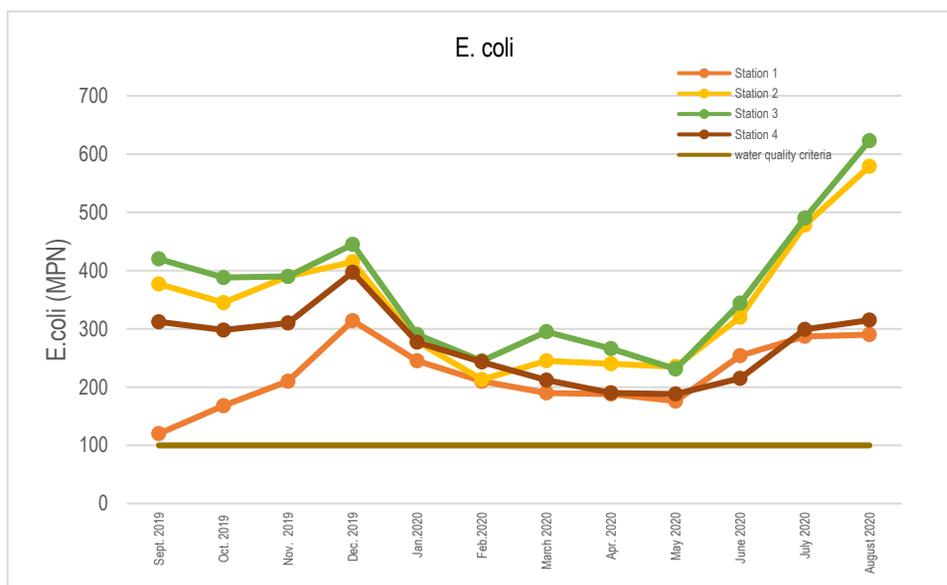
Fig. 5: Measured E. coli in the four sampling stations

pollution and indicator of contamination, diseases, and unsafe drinking (Ram *et al.*, 2008; Yogendra *et al.*, 2008). The E. coli is measured by the Most Probable Number per 100 mL of water sample (MPN/100 mL) and must not exceed 100MPN/100 mL for recreational uses (DENR-EMB, 2016). Results of the microbial analysis show the presence of E. coli in all water samples (Fig. 5). Higher values were measured in Station 3 particularly from November to December 2019 and from June to August 2020.
