CASE STUDY

A basis water quality monitoring plan for rehabilitation and protection

M.D. Enriquez *, R.M. Tanhueco

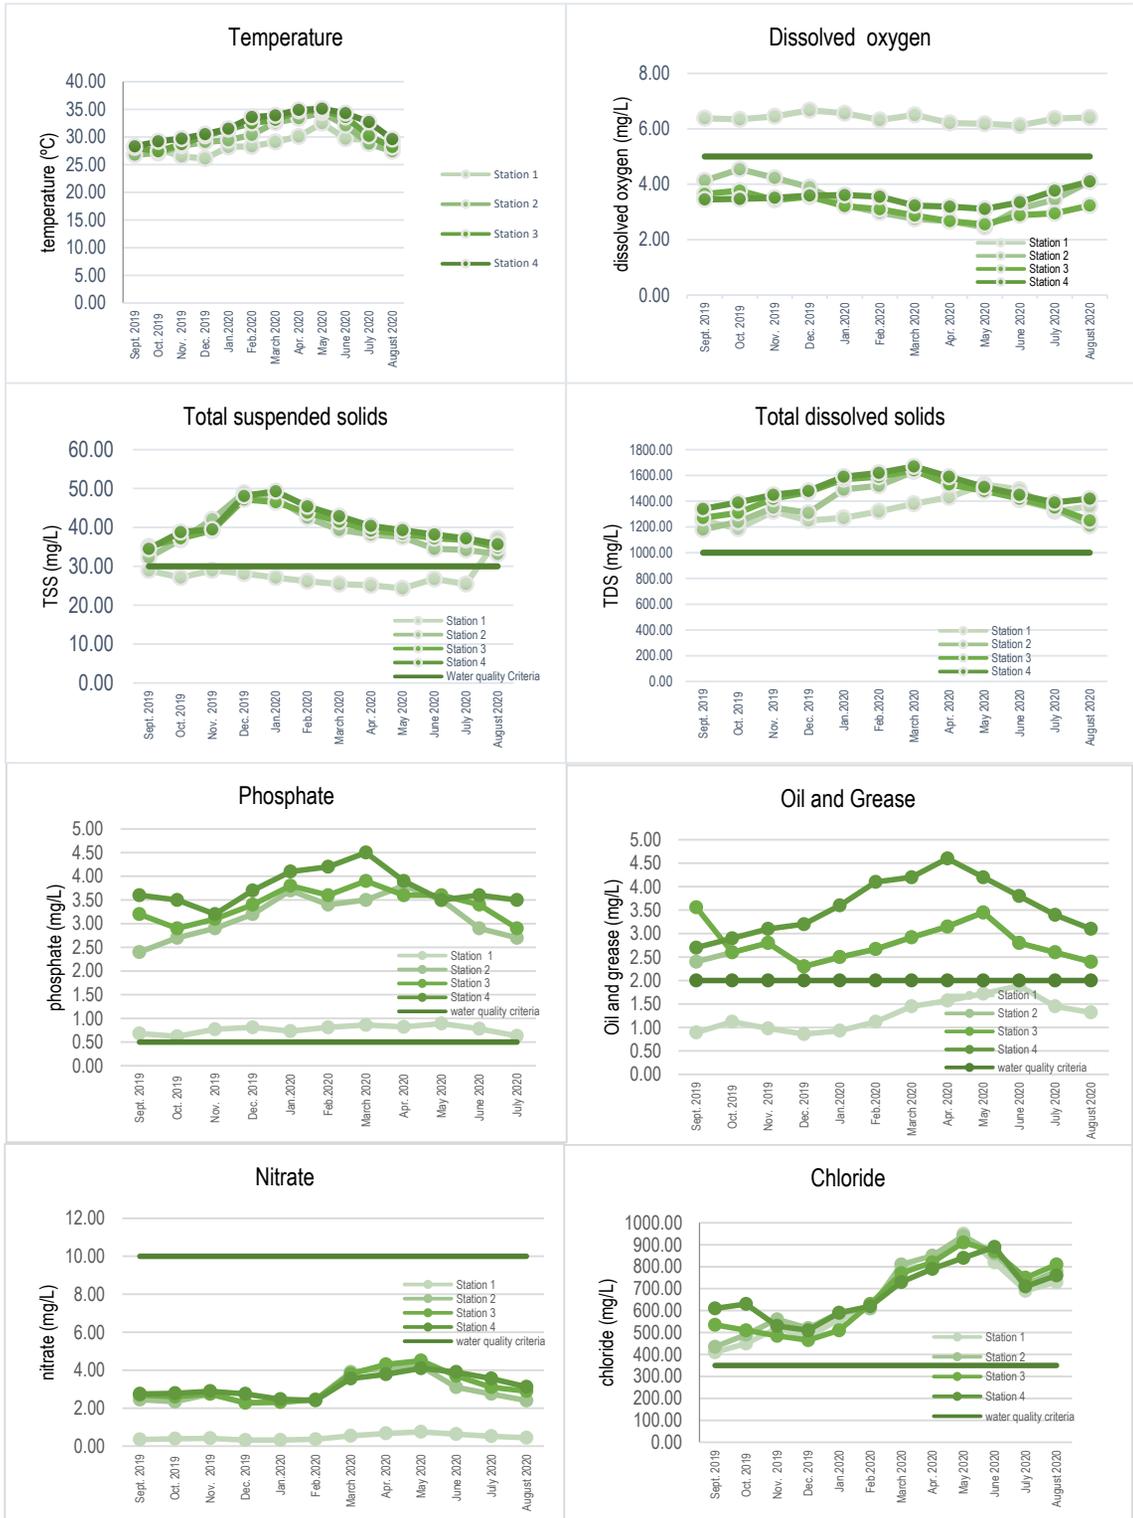
Fig. 4: Measured concentrations of physical –chemical water quality parameters in all stations

Following the procedures for in situ and laboratory analysis, the following results were observed. Water samples consider the wet season and dry season from September 2019 to August 2020 (Table 3). While, Fig. 4 shows the measured concentrations of each sampling station.

level below 5.0 mg/L compromises aquatic life and significantly indicates poor water quality (Liu *et al.*, 2009; Li and Bishop, 2004). Measured DO in stations 2, 3, and 4 showed higher values and beyond the allowable limit. Lower DO in the sampling station is manifested by limited aquatic life with only spire snail shells and other small crustaceans are present. While DOs measured in station 1 were higher than 5.0 mg/L indicating healthy water as fishes and other crustaceans are observed in the site. Suspended solids containing much organic matter may cause

with aerobic and anaerobic biological processes. Measured concentrations for oil and grease were higher during the dry months as it ranges between 1.08 to 3.5 mg/L with water samples from Station 1 conforms to the acceptable limit of 2 mg/L. Oil films are also observed in water surfaces of stations, 2, 3, and 4 indicating the presence of contaminants (Moslem et al., 2013) comprising the usability of the river system (US EPA, 1999). The allowable limit for nitrates concentration is 10 mg/L and an excessive amount may lead to algal bloom causing depletion of oxygen affecting the aquatic life (DENR-EMB, 2016). The measured concentrations of nitrate in the four sampling stations do not exceed the allowable limit but higher values were measured during March and May where agricultural activities are dominant in the surrounding environment as runoff from nitrogen fertilizers, domestic wastewater, human and animal waste are commonly observed (Wright et al., 2004). Chloride is a measure of sodium and potassium content of the water samples and must be less than 350 mg/L for freshwater (DENR-EMB, 2016). High chloride in the water body indicates saltwater intrusion. All water samples in all stations exceed the normal value for the freshwater significantly describing that the water is salty.
