CASE STUDY

A basis water quality monitoring plan for rehabilitation and protection

M.D. Enriquez *, R.M. Tanhueco

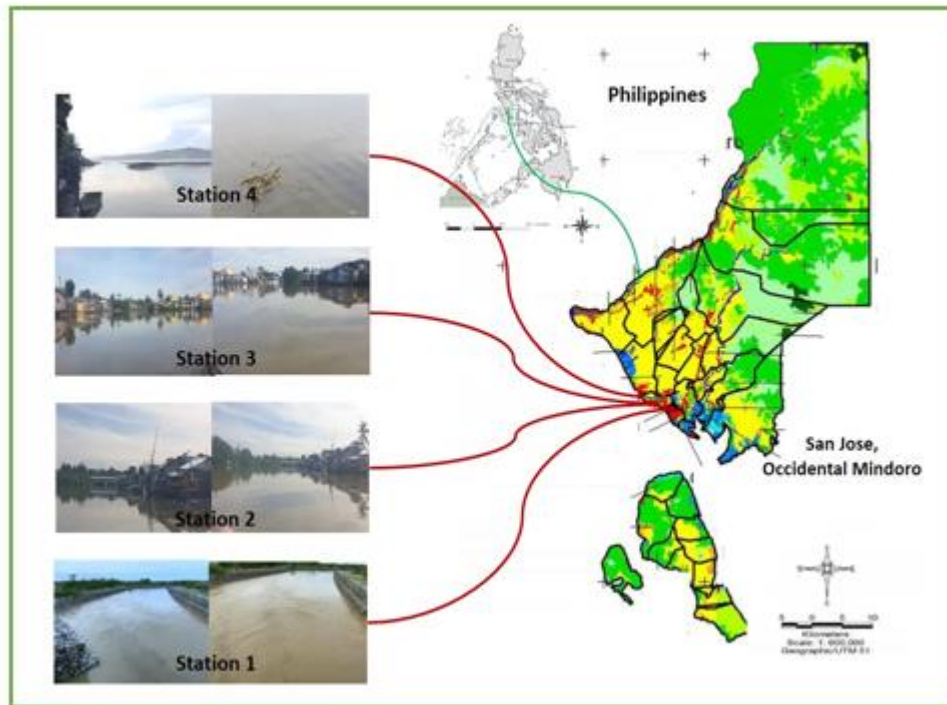
Fig. 1: Geographic location of the study sampling stations at San Jose, Occidental Mindoro, Philippines

Pandurucan River is located at San Jose, Occidental Mindoro covering San Roque and Labangan Poblacion on its midstream and downstream sections. The river is generally used for recreational purposes as swimming and bathing which are commonly observed and enjoyed. Four sampling stations were selected based on the drainage pattern and probable point sources and the center of commercial and residential areas. Table 1 shows the descriptions of the sampling stations.

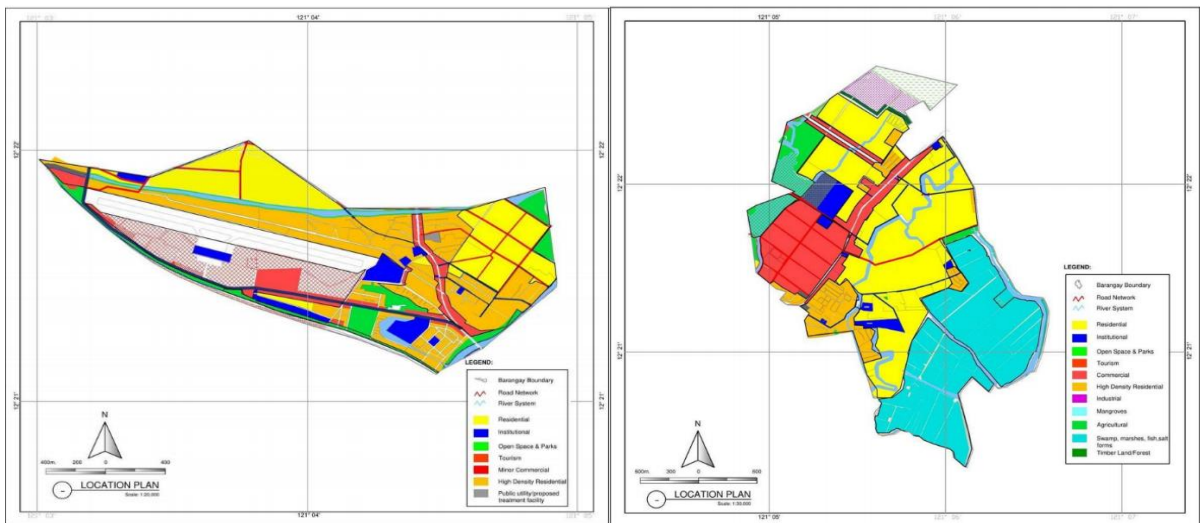
Fig. 2: General land use map of (a) San Roque (b) Labangan Poblacion (LGU San Jose, 2017)

In general, the land use pattern in San Roque is mostly covered with high-density residential: residential and minor commercial areas. Most of the commercial areas are found along the coast of Aroma Beach and San Jose Airport. The coastal barangay of San Roque is located just a kilometer away from the town of San Jose along the Pandurucan River separating it from the town (Fig. 2). The mode of transportation is mostly thru tricycles that can roam around the town via cemented roads. On the Eastern part of the area is the town proper of San Jose and Bubog: North (LGU San Jose, 2017).

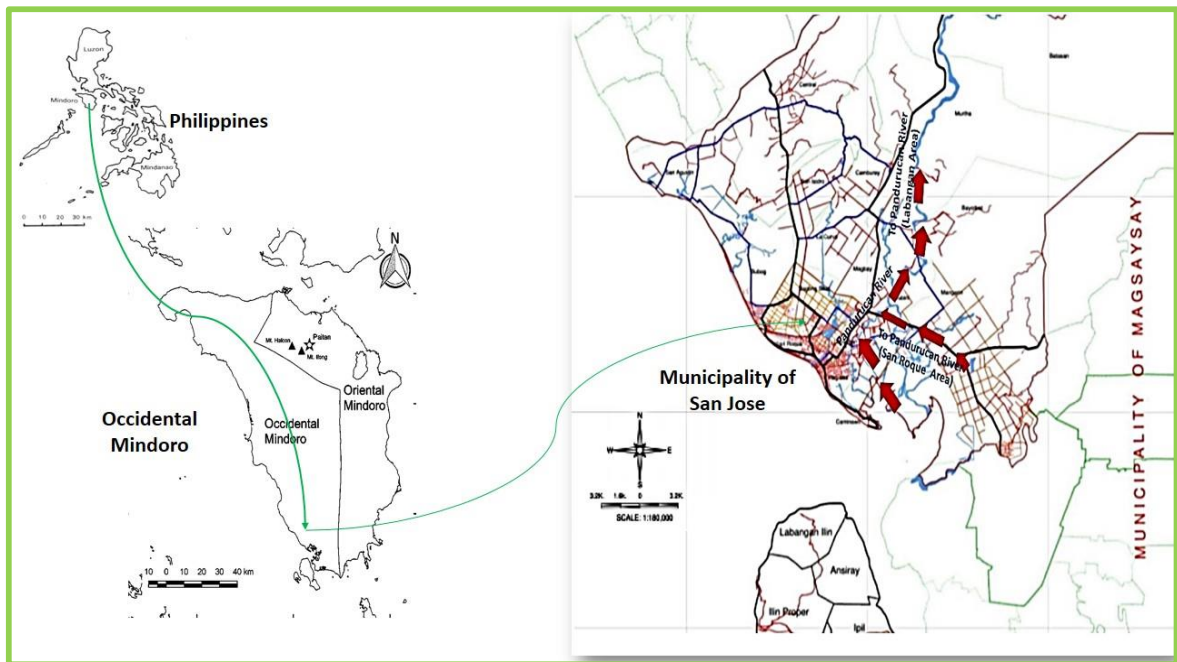
Fig. 3: Geographic location of the study area along with the existing drainage system in San Jose, Occidental Mindoro, Philippines

Drainage pattern can also affect the river system as it determines contributing factors and possible sources of contamination. In general, drainage in San Jose is composed of curb type and steel grated box type. However, there are still some areas in the municipality that do not have a reliable drainage system. All existing curbs and gutters in the municipality drain water to the Pandurucan River. While those that are in the area of San Roque drain water in the Bubog River. Fig. 3 shows the drainage system in the study area.

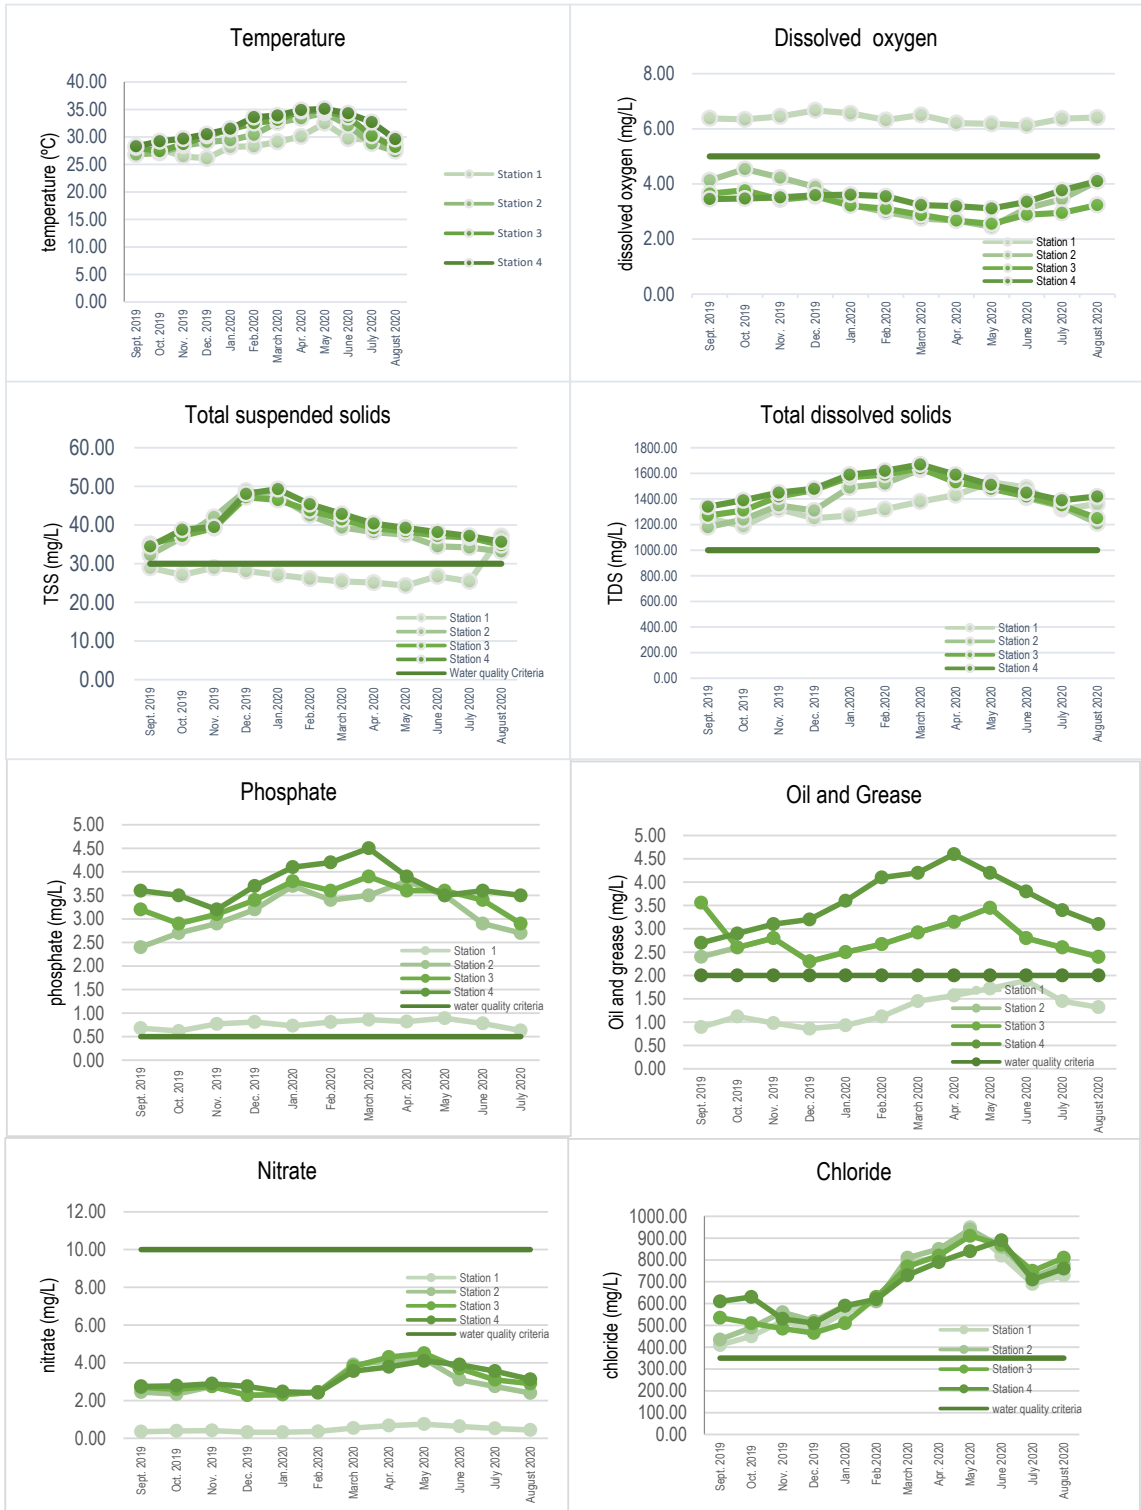
Fig. 4: Measured concentrations of physical –chemical water quality parameters in all stations

Following the procedures for in situ and laboratory analysis, the following results were observed. Water samples consider the wet season and dry season from September 2019 to August 2020 (Table 3). While, Fig. 4 shows the measured concentrations of each sampling station.

level below 5.0 mg/L compromises aquatic life and significantly indicates poor water quality (Liu *et al.*, 2009; Li and Bishop, 2004). Measured DO in stations 2, 3, and 4 showed higher values and beyond the allowable limit. Lower DO in the sampling station is manifested by limited aquatic life with only spire snail shells and other small crustaceans are present. While DOs measured in station 1 were higher than 5.0 mg/L indicating healthy water as fishes and other crustaceans are observed in the site. Suspended solids containing much organic matter may cause

with aerobic and anaerobic biological processes. Measured concentrations for oil and grease were higher during the dry months as it ranges between 1.08 to 3.5 mg/L with water samples from Station 1 conforms to the acceptable limit of 2 mg/L. Oil films are also observed in water surfaces of stations, 2, 3, and 4 indicating the presence of contaminants (Moslem et al., 2013) comprising the usability of the river system (US EPA, 1999). The allowable limit for nitrates concentration is 10 mg/L and an excessive amount may lead to algal bloom causing depletion of oxygen affecting the aquatic life (DENR-EMB, 2016). The measured concentrations of nitrate in the four sampling stations do not exceed the allowable limit but higher values were measured during March and May where agricultural activities are dominant in the surrounding environment as runoff from nitrogen fertilizers, domestic wastewater, human and animal waste are commonly observed (Wright et al., 2004). Chloride is a measure of sodium and potassium content of the water samples and must be less than 350 mg/L for freshwater (DENR-EMB, 2016). High chloride in the water body indicates saltwater intrusion. All water samples in all stations exceed the normal value for the freshwater significantly describing that the water is salty.

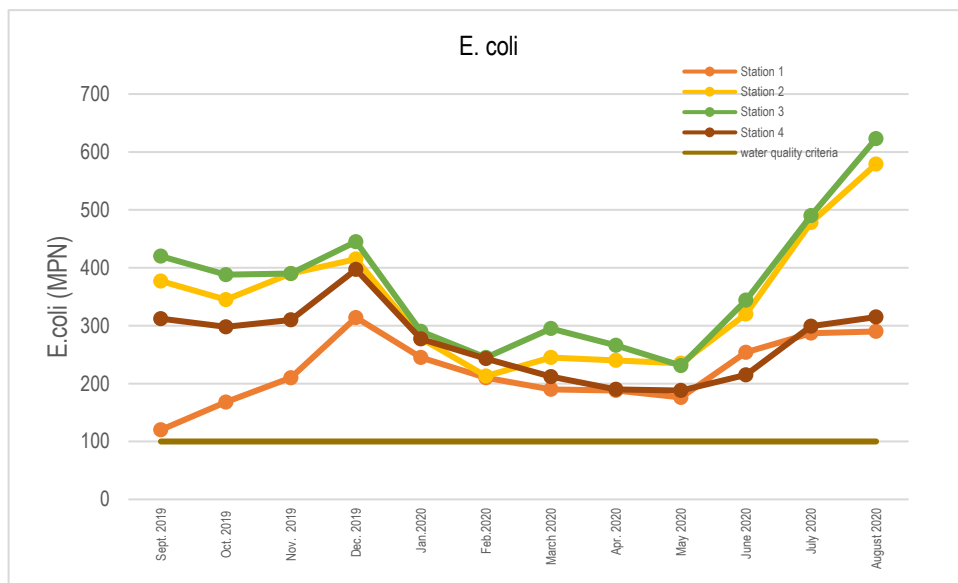
Fig. 5: Measured E. coli in the four sampling stations

pollution and indicator of contamination, diseases, and unsafe drinking (Ram *et al.*, 2008; Yogendra *et al.*, 2008). The E. coli is measured by the Most Probable Number per 100 mL of water sample (MPN/100 mL) and must not exceed 100MPN/100 mL for recreational uses (DENR-EMB, 2016). Results of the microbial analysis show the presence of E. coli in all water samples (Fig. 5). Higher values were measured in Station 3 particularly from November to December 2019 and from June to August 2020.
